Machinery Messages

Case History

ADRE® for Windows saves a generator

by Mogens Greve
Engineer B.S.C.M.E.
Asnæs Power Station
Denmark

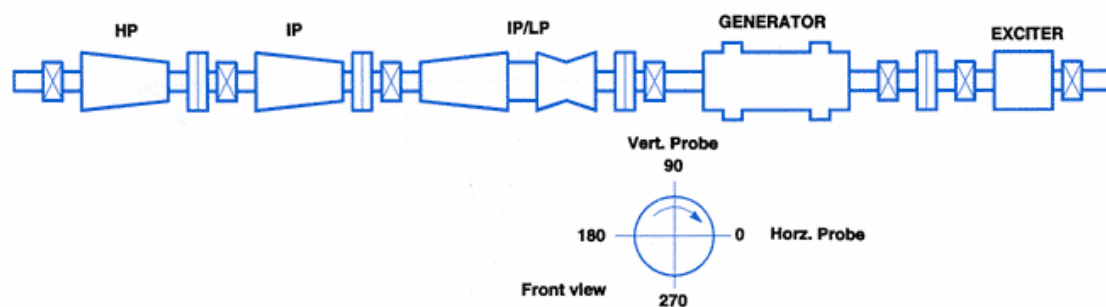
Figure 1:
Asnæs Turbine Unit 1 machine train diagram.

Asnæs' Unit No. 1 consists of a high pressure (HP) turbine, intermediate turbine (IP), combined intermediate and low pressure turbine (IP/LP), and a generator (Figure 1). Since its commissioning in 1959, Unit 1 has operated approximately 200,000 hours. In 1985, it was rebuilt and upgraded to 150 MW. The HP and IP turbines were replaced, the combined IP/LP turbine had new turbine blades installed, and the two-pole generator windings and retaining rings were also replaced.

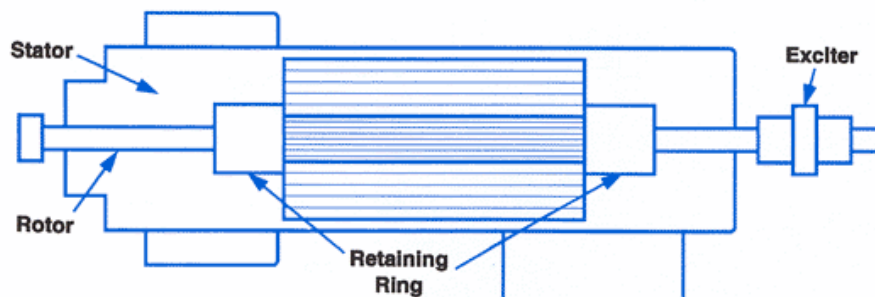
Figure 4:
Cutaway drawing of generator showing windings and retaining rings.

body. A single bar on top of the upper copper bar is called the "damping winding bar." Retaining rings hold the generator windings in place at each end of each pole. Electrical insulation between the retaining rings and generator windings prevents the windings from shorting on the retaining rings (Figure 4). We suspected either that grooves in the damping winding bar were pressing against the retaining rings or that the indirectly-cooled copper bar windings were pressing against the backplate of the retaining rings.

When we inspected the generator rotor, we saw that the generator windings were displaced axially by approximately 10 mm (394 mils) (Figure 5). The winding coils at one pole were pressing toward the retaining ring backplate, yielding unsymmetrical axial forces that preloaded and bent the rotor body, causing the increased 1X vibration. Further axial displacement could have led to a winding short circuit, as two of the windings were close to each other. This could have caused a more severe generator failure.

The rotor is currently under repair at Asnæs Power Station (Figure 6). Three OEM specialists and 18 Asnæs Power

Station employees are working in three shifts dismantling, straightening and reinstalling 12 of the 16 winding coils. We are modifying the bearing housing to reduce its structural resonance. **We also decided that we need better vibration information than can be provided by seismic, housing-mounted probes. On machines with fluid-film bearings, much of the energy generated by machine malfunctions is not transmitted to housing-mounted transducers. Proximity probes that directly observe the rotor provide much better diagnostic information. Therefore, in addition to seismic probes, we are installing XY proximity probes on each bearing.**
